Effective Controls For Corundum Growth That Improve Quality and Cut Costs

Conquering Aluminum Furnace Corundum

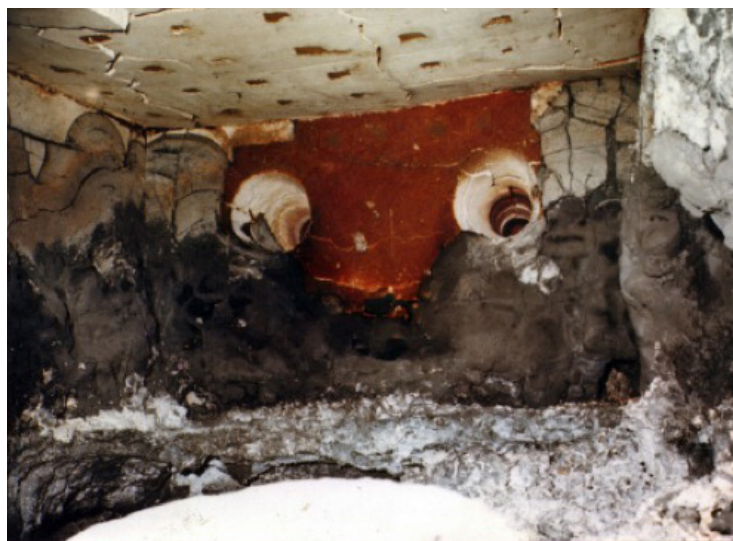
Corundum under heat expansion cracks the refractory.

Corundum formation can occur both externally and internally in the refractory lining. External corundum grows above the metal line outward from the hot face of the refractory lining, often appearing as mushroom-shaped corrosion. Heat and atmospheric oxygen feed this reaction in the furnace chamber. Corundum formation begins at the point where the molten aluminum, refractory wall, and atmosphere meet. It then wicks through the wall. As a result, the formation ultimately creates a volume expansion, which causes cracking and reduces mechanical strength. The basic formula for this reaction is:
